HOME SWEET HOME INSPECTIONS

CONFIDENTIAL INSPECTION REPORT

399 N Doeskin Place, Tucson, AZ 85748

SUMMARY REPORT

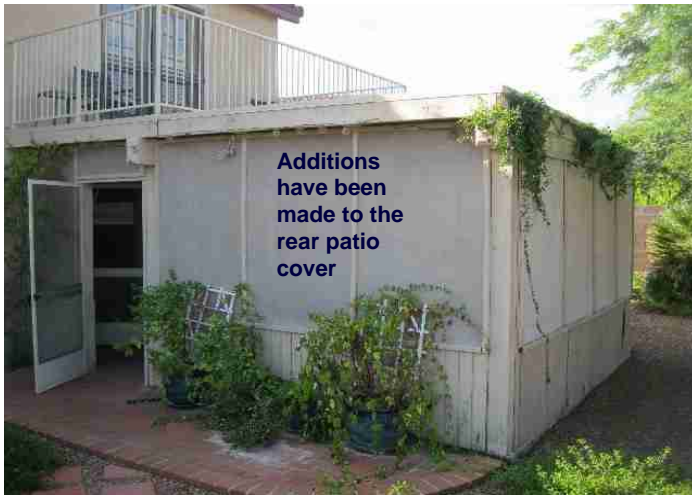
- 1.1 - m Additions have been made to this property. Therefore, you should request documentation that should include permits and any warranties or guarantees that might be applicable, because we do not approve of, or tacitly endorse, any work that was completed without permits, and latent defects could exist.

Additions have been made to the rear patio cover and you should request documentation for your records - *Continued*

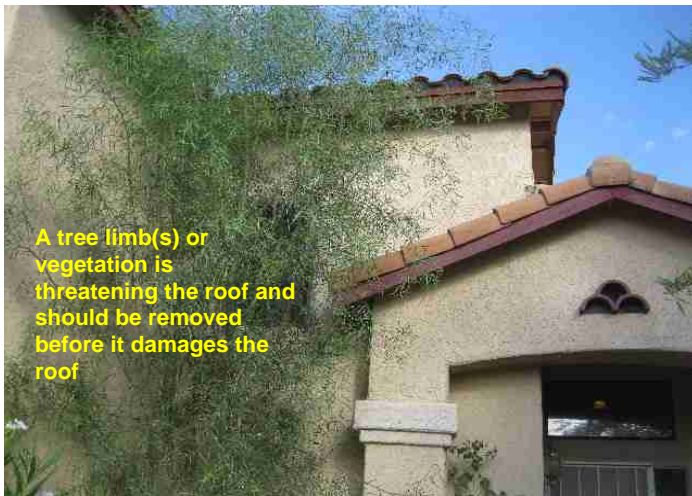
1.2 - v A tree limb(s) or vegetation threatening the roof at the North & East side and should be removed by an arborist before it further damages the roof.

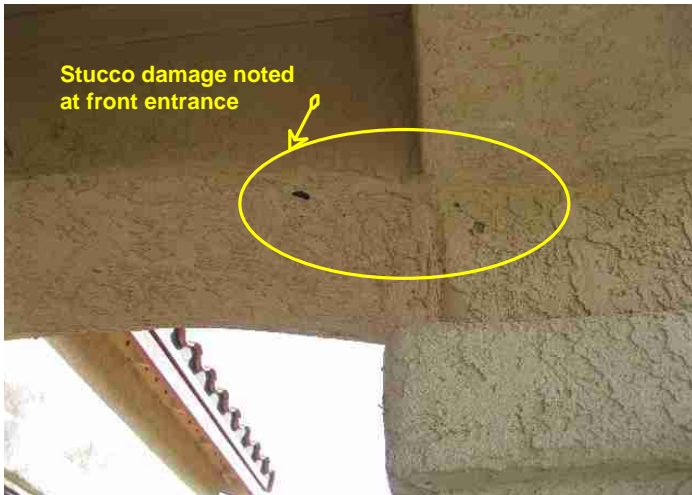
1.9 - v Stucco damage noted at the front entrance. (Recommend repairing damaged stucco to prevent moisture intrusion & further deterioration).

Stucco damage noted at - *Continued*

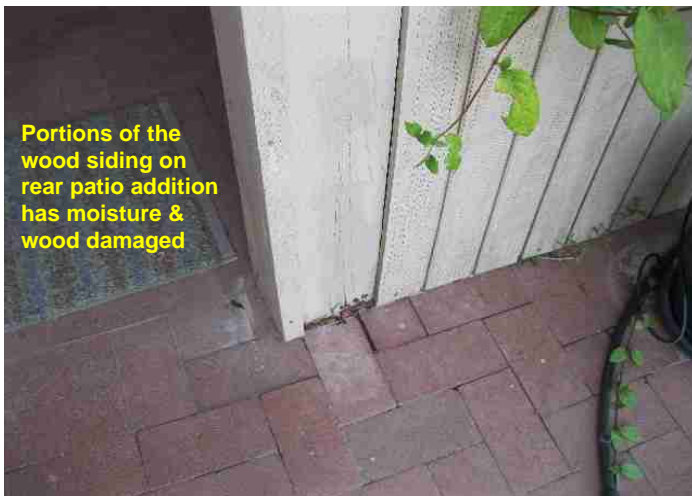
- 1.10 - √ The paint is peeling in places, as a result of inadequate bonding or normal wear around structure. We recommend repair to prevent further deterioration.
- 1.11 - √ Portions of the wood siding and trim have moisture & wood damage, and should be evaluated by a termite inspector.

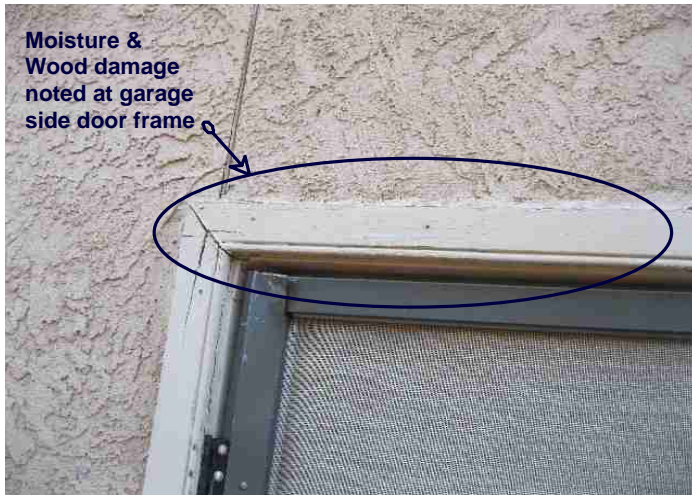
- 1.12 - √ There are separations or nail-pops on wood siding that needs to be serviced. We recommend repair.
- 1.13 - √ The wood siding on rear patio structure(s) is down to the soil or grade without the benefit of a weep-screed. Weep screed is a horizontal strip of metal that isolates the wood siding walls from the foundation and allows them to move independent of the foundation. It isolates the siding from the soil and inhibits the wicking effect of moisture being drawn up into the wood siding which in turn creates moisture wood deterioration.
- 1.14 - √ Moisture & Wood damage noted on garage side door frame . We recommend further review & repair.

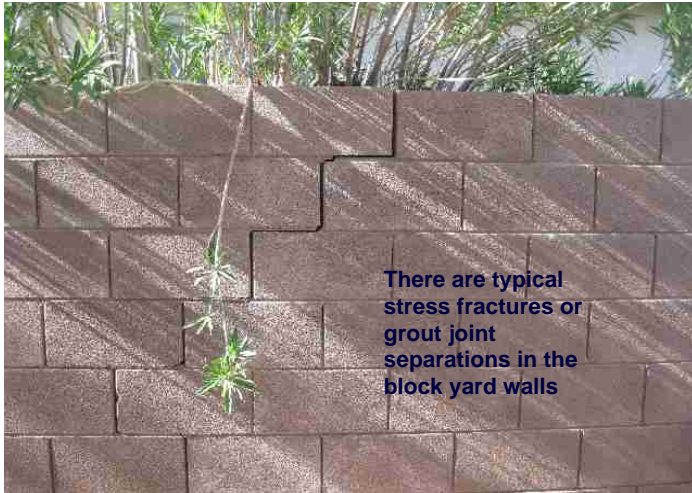
1.19 - m There are typical stress fractures or grout joint separations in the block yard walls, but they are reasonably firm and not in any danger of falling.

There are typical stress fractures or grout joint separations in the block yard walls - *Continued*

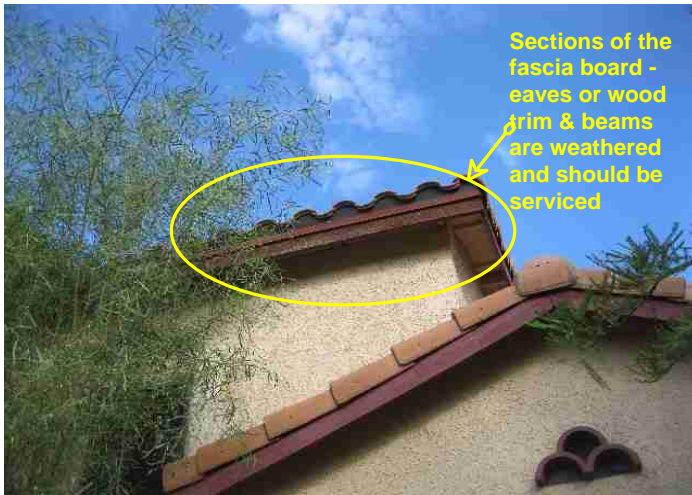
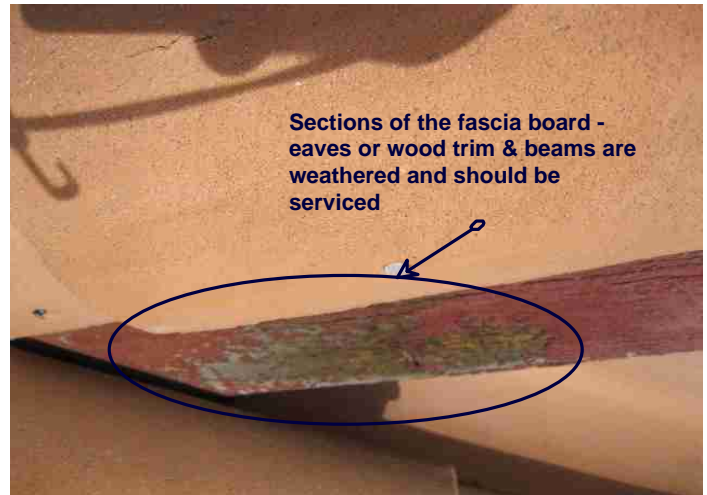
1.22 - v Sections of the fascia board - eaves or wood trim are weathered , and should be serviced to prevent further deterioration.

Sections of the fascia board - eaves or wood trim & beams are weathered and should be serviced - *Continued*

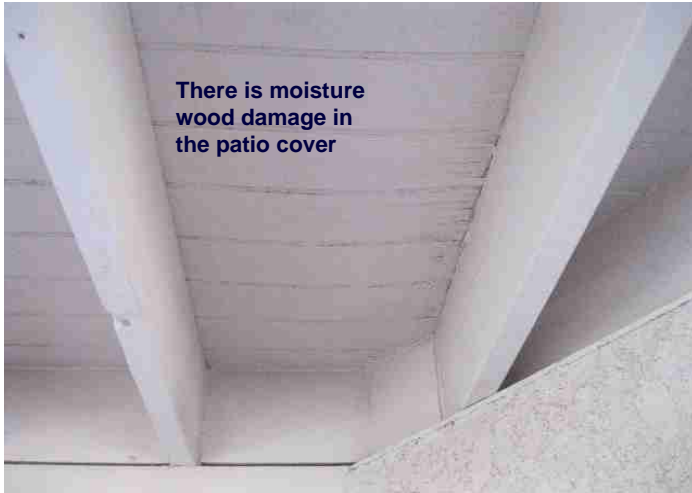
1.26 - v There is moisture wood damage in the patio cover. Recommend further review & repair.

There is moisture wood damage in the patio cover - *Continued*

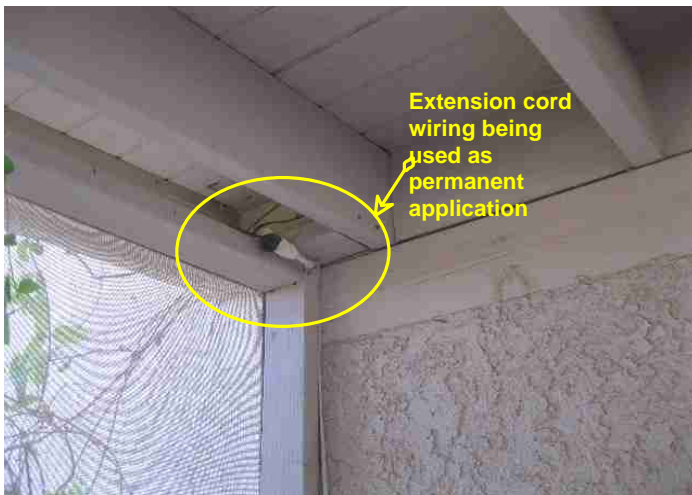
1.27 - √ Extension cord wiring being used as permanent application for lighting noted at rear yard. We recommend repair.

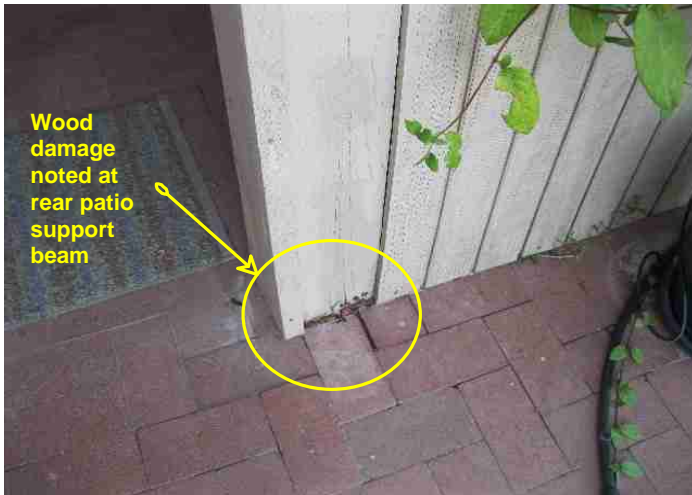
1.28 - √ Wood damage noted at rear support beam. We recommend repair.

Wood damage noted at rear patio support beam - *Continued*

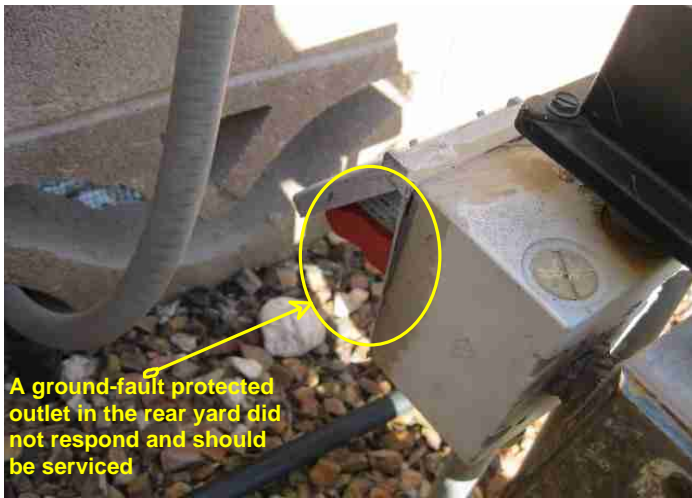
1.38 - v A ground fault protected outlet in the rear yard did not respond, and should be serviced.

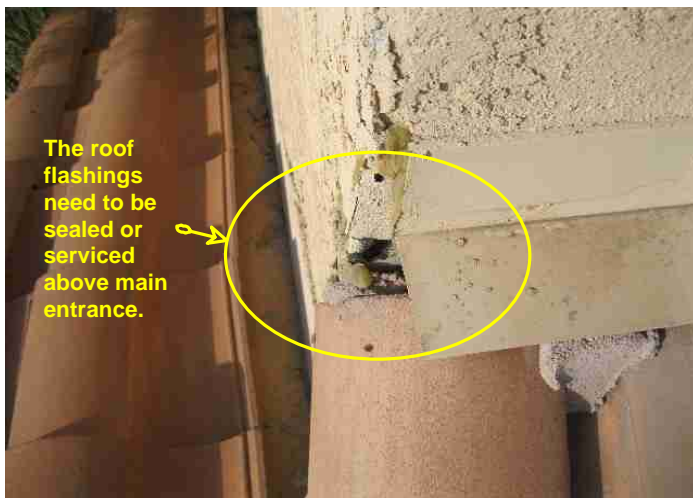
3.7 - v The roof flashing's need to be sealed or serviced above main entrance. They are comprised of metal that seals valleys and vents and other roof penetrations, and are the most common point of leaks. This is particularly true of the flashing's on a layered roof, which are covered by the roofing material and

which are even more susceptible to leaks.

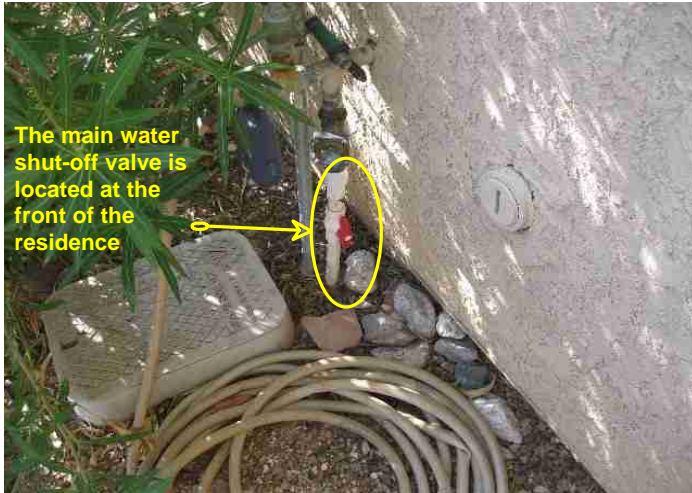
- 5.1 - m The main water shut-off valve is located at the front of the residence.

The main water shut-off valve is located at the front of the residence - *Continued*

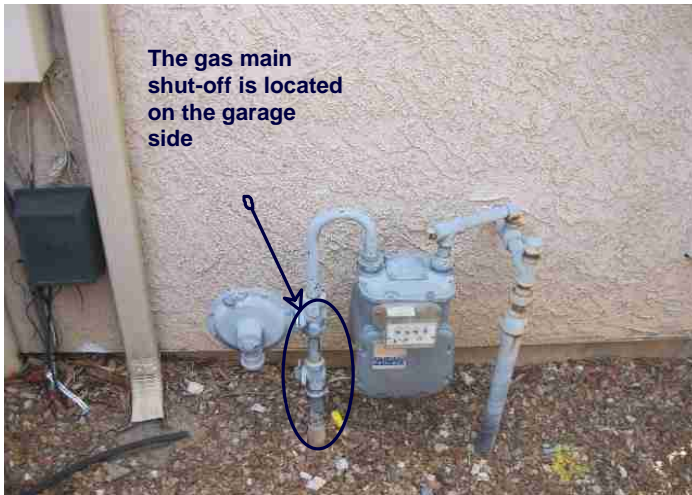
5.6 - m The gas main shut-off is located on the garage side. You should be aware that gas leaks are not uncommon, particularly underground ones, and that they can be difficult to detect without the use of sophisticated instruments, which is why natural gas is odorized in the manufacturing process. Therefore, we recommend that you request a recent gas bill from the sellers, so that you can establish a norm and thereby be alerted to any potential leak.

The gas main shut-off is located on the garage side - *Continued*

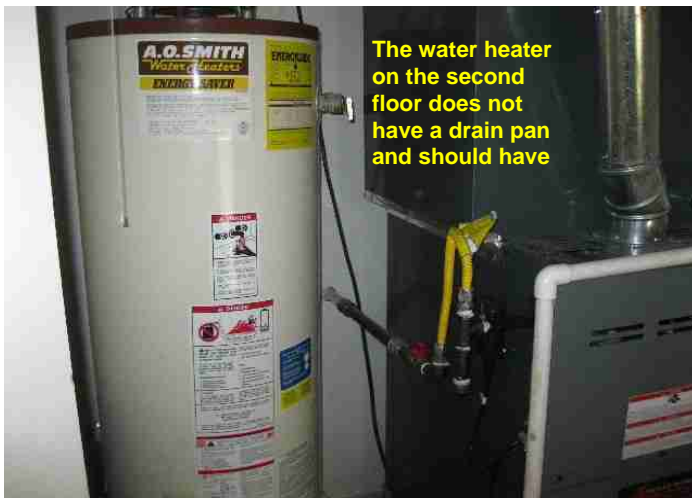
5.16 - √ The water heater on the second floor does not have a drain pan, and we recommend having one installed that is plumbed to the exterior, or otherwise engineered to prevent or minimize moisture damage from a leak.

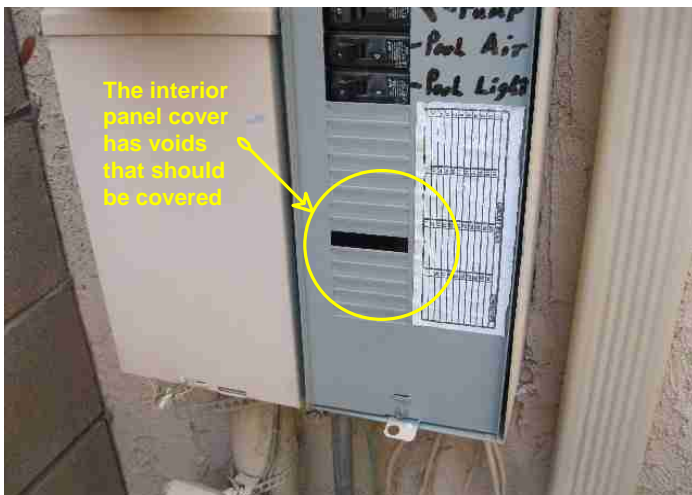
6.6 - v The interior cover panel has voids or open knockouts that should be covered.

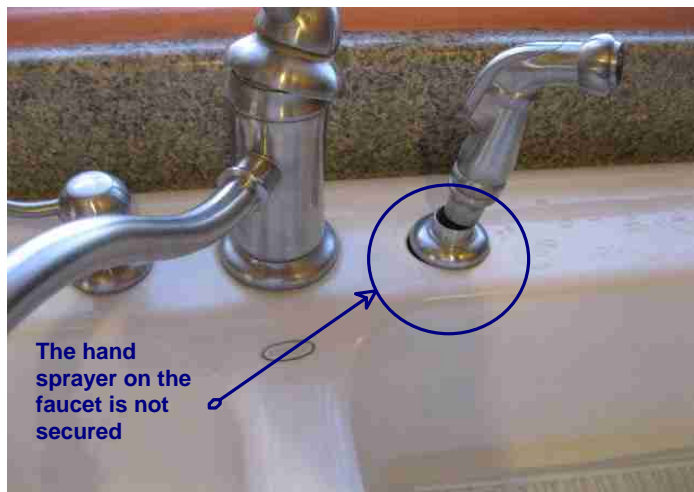
10.8 - v The hand sprayer on the faucet is not secured. Recommend repair.

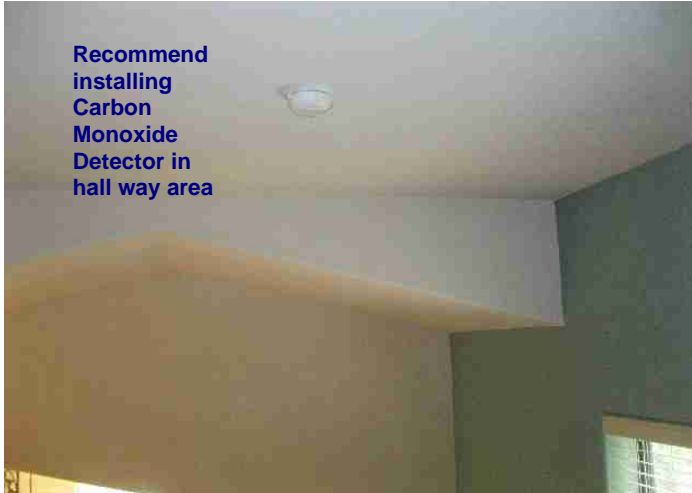
12.8 - v Recommend installing Carbon Monoxide Detectors in all hallway areas to bedrooms. (SAFETY ASPECT)

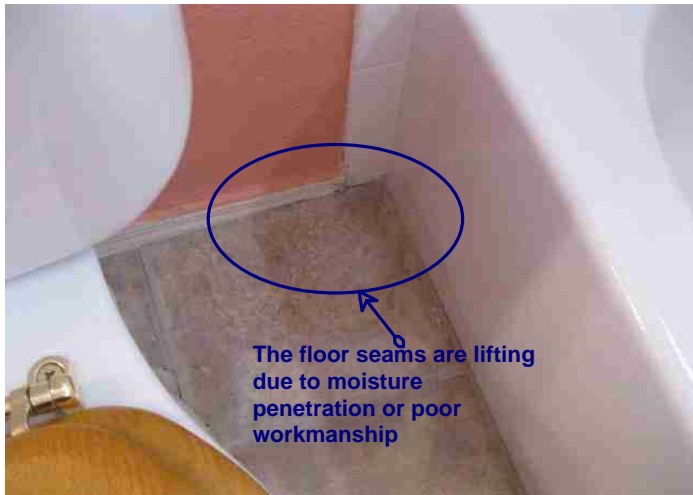
15.4 - v The floor seams are lifting, due to moisture penetration or poor workmanship.

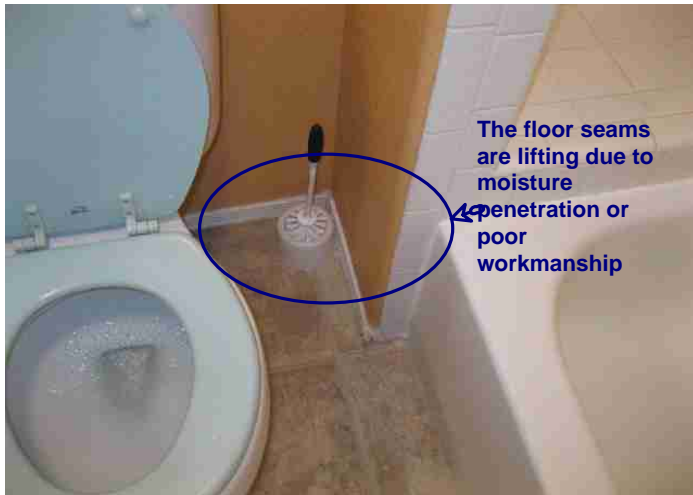
15.20 - vThe floor seams are lifting, due to moisture penetration or poor workmanship. We recommend repair.

The floor seams are lifting due to moisture penetration or poor workmanship - *Continued*

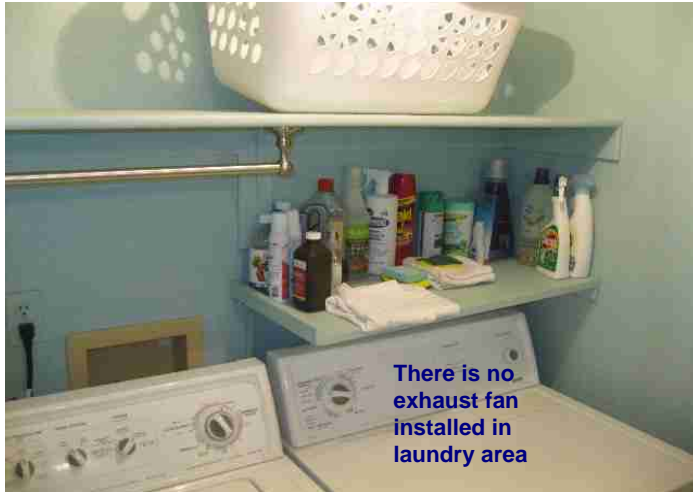
16.4 - √ There is no exhaust fan installed in laundry area. We recommend repair.

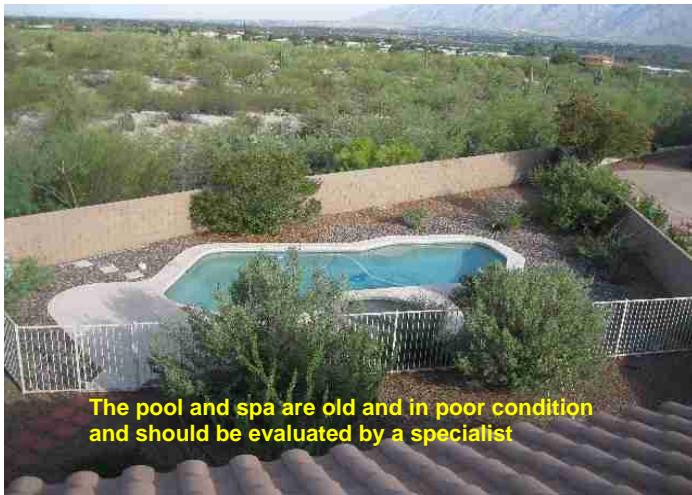
18.4 - v The pool and spa are old and in poor condition, and you should have them evaluated by a pool and spa specialist with a view to having them renovated.

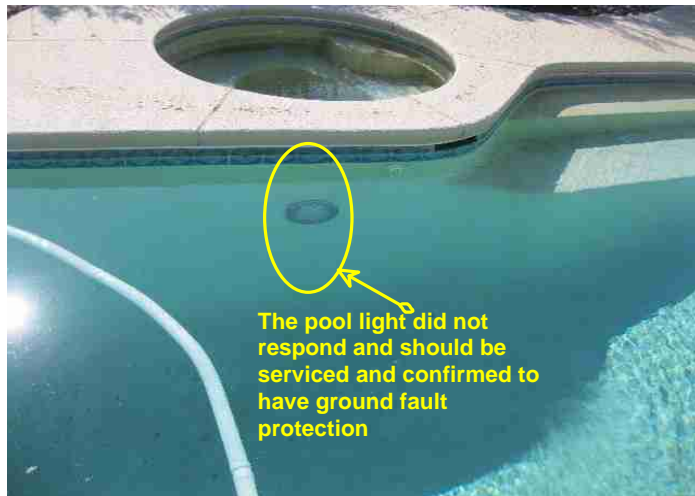
18.12 - v The pool light did not respond, and should be serviced, confirmed to have ground-fault protection.

However, for reasons of safety, the circuit should be tested periodically to ensure that its ground fault protection is functional.

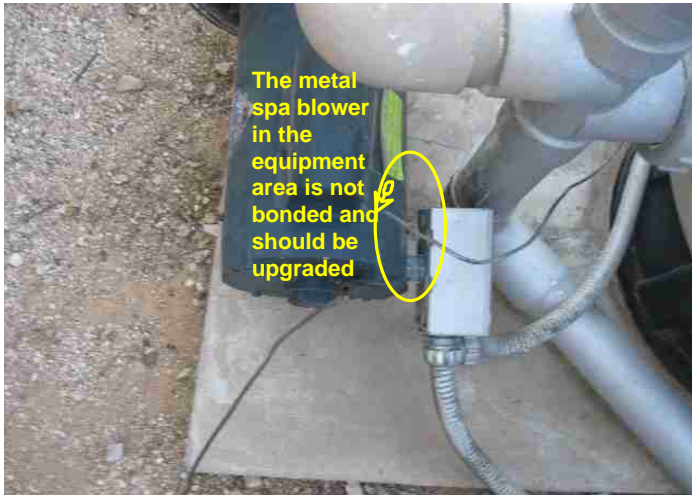
18.14 - v National electrical standards require the metal blower in the equipment area to be attached to a common bonding wire that conveys errant electricity harmlessly to ground, which we recommended as a safety upgrade.

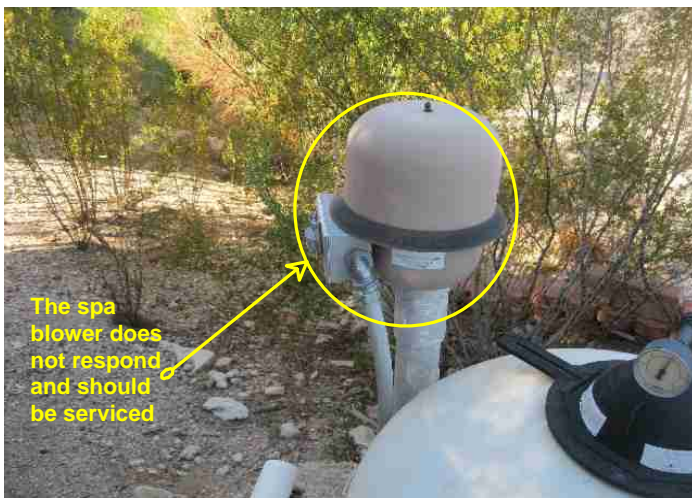
18.15 - ✓The blower did not respond to its controls, and should be serviced.

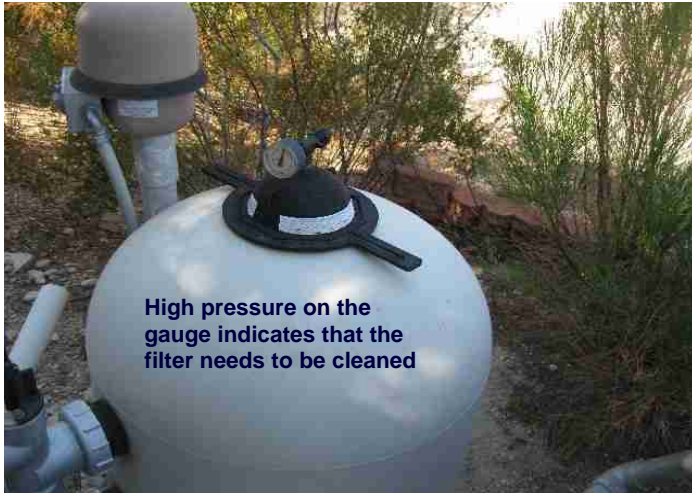
18.18 - ✓The pressure on the filter gauge is high, which usually indicates that the elements within the filter need to be cleaned.

High pressure on the gauge indicates that the filter needs to be cleaned - *Continued*

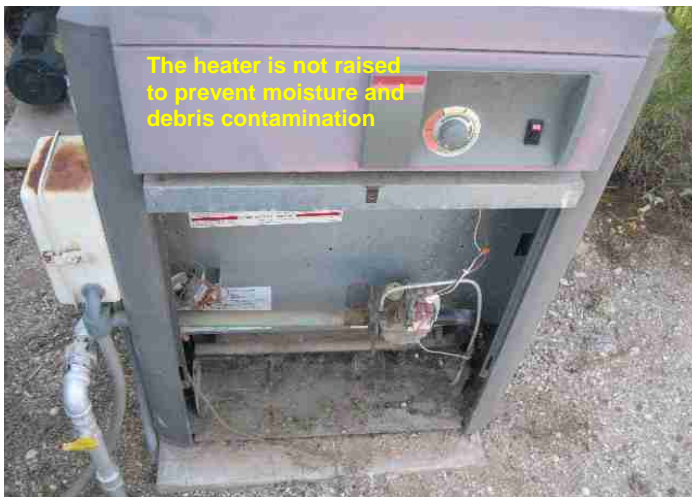
18.19 - √The pool/spa heater has been shut down at the unit. It should be serviced and demonstrated by a pool specialist.

18.20 - √The heater is not raised to prevent moisture and debris contamination, but not the recommended height of three inches above the surrounding grade, which you may wish to view for yourself before deciding to take further action.
